NASA/ESA CV-990 SPACELAB SIMULATION

FINAL REPORT

APPENDIX B – EXPERIMENT DEVELOPMENT AND PERFORMANCE

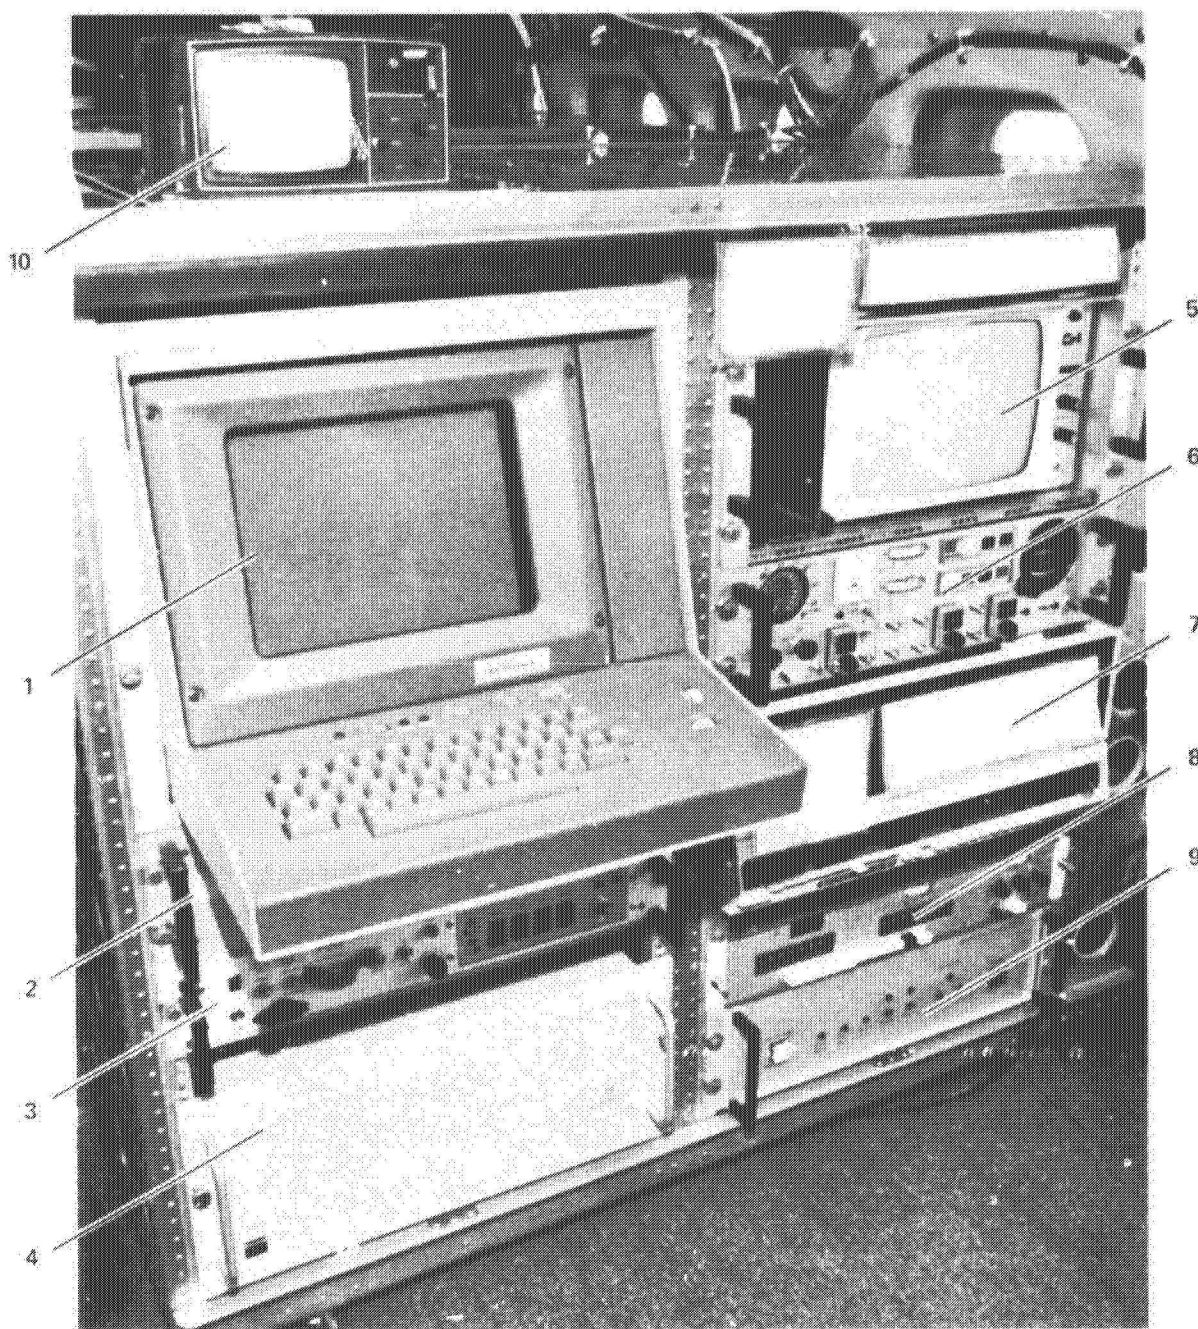
Figure B-17.- Meudon equipment configuration, right middle rack H.

Efforts to localize the most frequently adjusted controls of this experiment were generally successful: telescope controls were mounted on the rear of the rack H (fig. B-17), and the photometer/spectrometer controls were immediately to the rear on the forward side of rack I (fig. B-18). Unfortunately, this arrangement left no provision for regular aircraft seats from which to operate either rack. For some reason, the EO eschewed the use of a short stool (regularly available and frequently used to operate or repair components positioned near the floor; instead, he preferred to operate from a kneeling or sitting position. Telescope controls (fig. B-17) requiring the most frequent hands-on activities were located on components 1, 2, and 6. Most photometer controls (fig. B-18) were located on components 1 and 2. Photometer signals were recorded on the Ames stripchart (3 in fig. B-21), where they were annotated with experiment control settings, etc. The PI originally intended to control the tape recorder mounted on the lowboy rack (fig. B-16) from this central control area (component 3, fig. B-17). However, the central control circuitry did not function properly during experiment installation at Ames, and during the press of resolving much more serious problems the PI decided to forego this operational refinement.
